Building Description

This is a stone, brick and wood structure that was built in approximately 1899 and has recently undergone a complete renovation. It is a 3 ½ story building that house 2 residential units and a basement below the garden level unit. The property also includes a back yard that has been finished with a stone patio and small garden space. We will proceed to report on the readily accessible structural and mechanical components of the building and also to report any apparent safety or health issues.

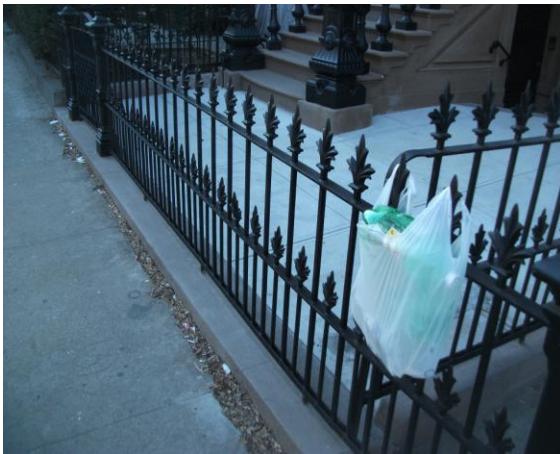
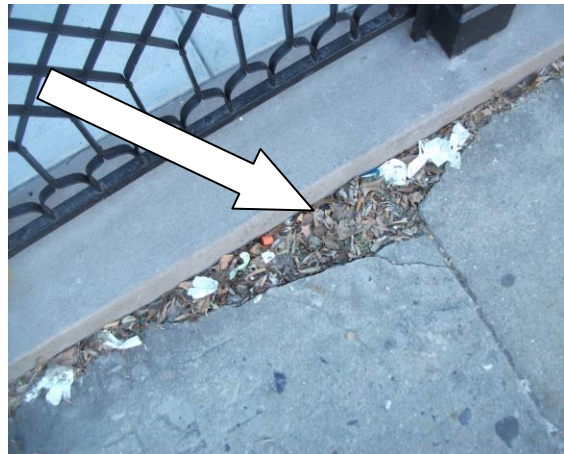
The property and side walk at the front of the building slopes away from the house which helps to prevent water intrusion to the basement. The patio inside the front gate is new and the sidewalk here is in fairly good condition. A crevice was noted just before the entry gate. I would have the hole filled with concrete to avoid further cracking which could result in a possible trip hazard.

- 1-Fill crevice in sidewalk at front of building.
- 2- Keep storm drains clear at all times.
- 3- Re-coat roof periodically.
- 4- Patch where roofing meets neighbors wall and install the proper wall flashing when you install a new roof.
- 5- Repair front door bell.
- 6- Remove marks or scuffs from stair treads.

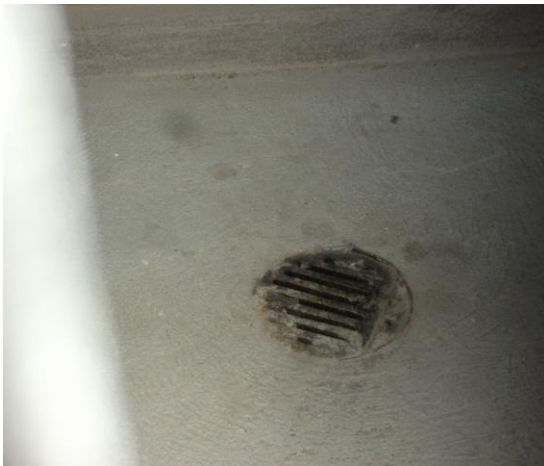
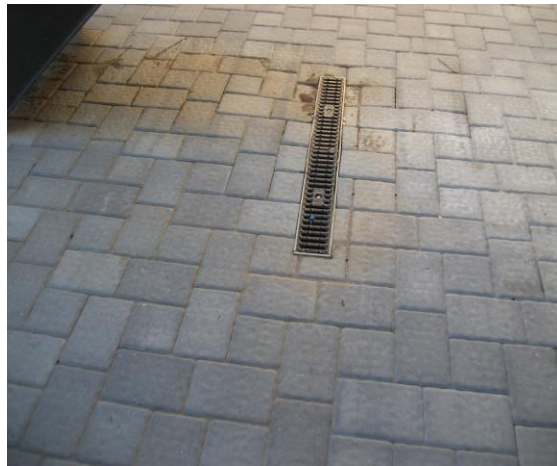
The recommended storm drains were observed at both front and rear of the building to extract any excess surface water. I would keep these drains clear and free of debris at all times.

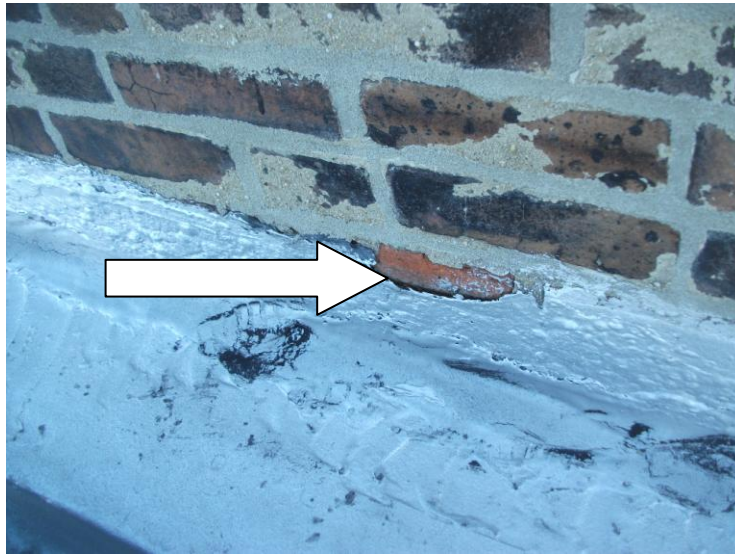
Where the roof edge terminates along the common wall with the neighboring building you can see a chip in the sealant. I would recommend having this edge examined and sealed. I would install the proper wall flashing when you install a new roof.

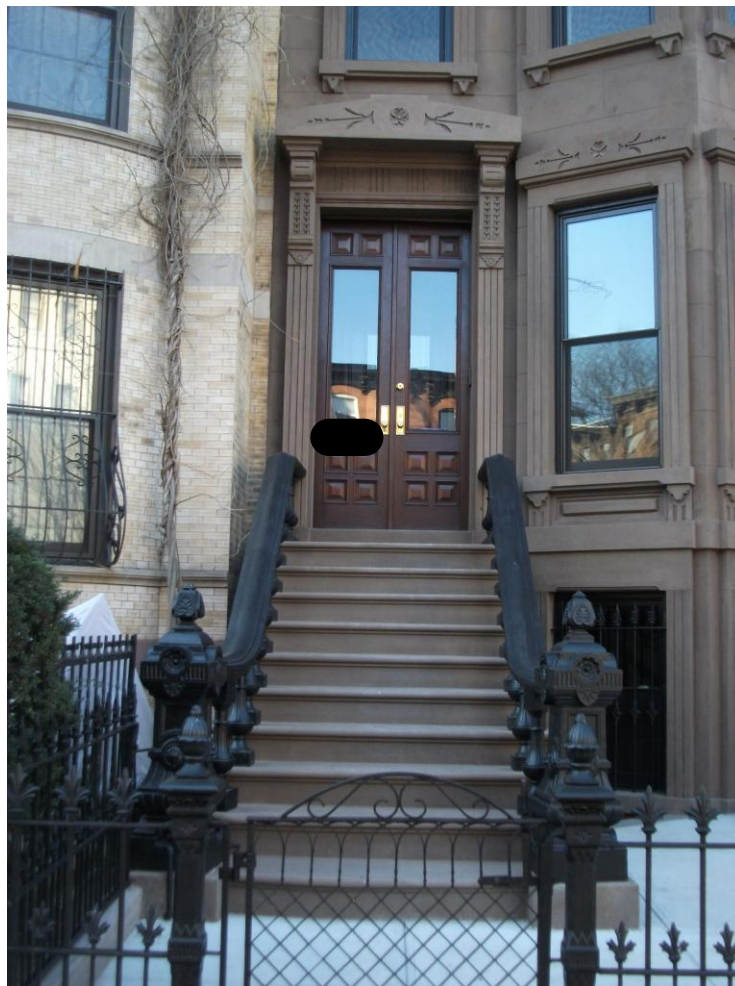
Ten concrete steps rise to the wood and glass doors at the building's entry. The steps appeared to be in good condition. No cracking or evidence of unusual settling was observed. These steps are flanked by the appropriate handrails that were found to be properly secured. The doors, locks and hardware were all in good working order and no sagging or unusual settling were found in or around the door frame. We were not able to get the front door bell to ring. Since it is new it will probably be an easy fix.

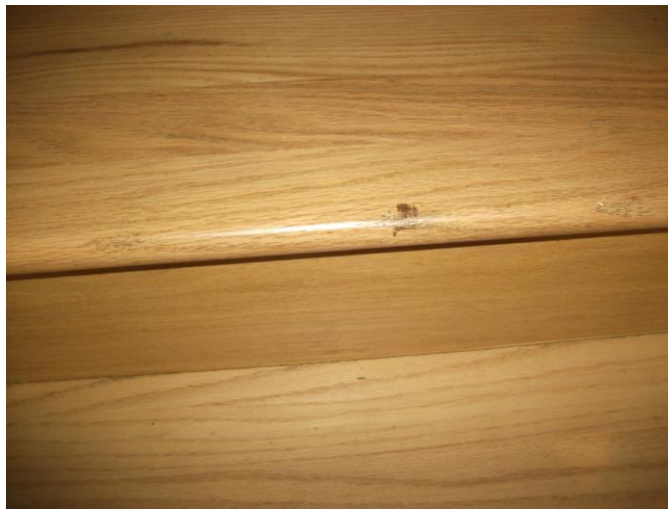
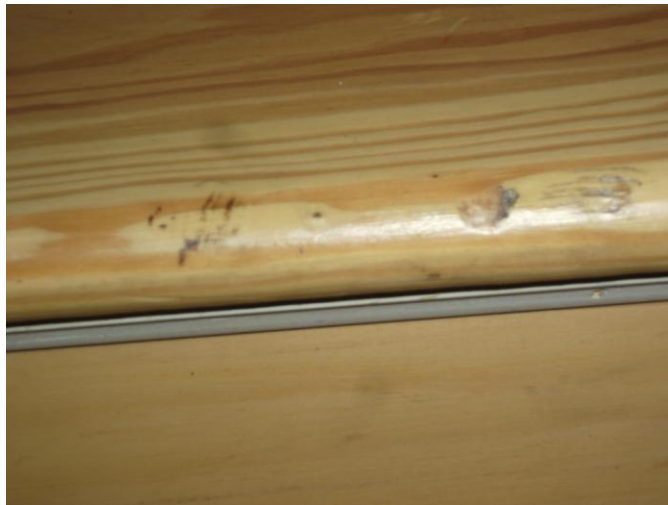
The stairs throughout this house are constructed of wood. No loose stair treads or unusual squeaking was noted. Each step appeared to be sound and stable. However a few dark spots or scuffs were observed on both the oak steps to the 2nd floor and the yellow pine steps to the 3rd floor. I would ask to have these marks or scuffs removed or buffed out.

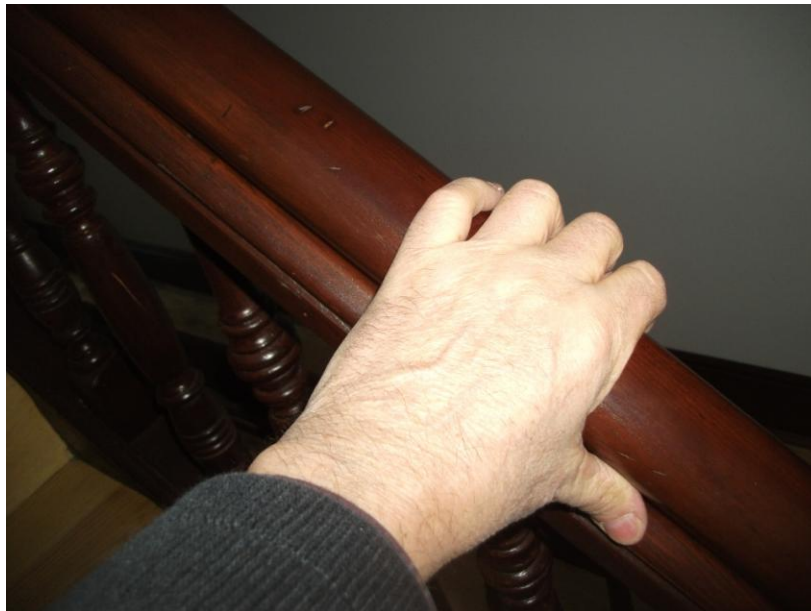
However the newel post on the 2nd floor landing will need to be secured to strengthen the railing to the 3rd floor.

- 7- Secure newel post on 2nd floor landing.
- 8- Replace wood flooring on first floor.
- 9- Fill and finish gaps in wood floor on upper and garden levels.
- 10- Examine and seal bathroom floor perimeters.
- 11- Install magnets or catches on laundry closet doors.
- 12- Adjust master closet door not to rub.
- 13- Secure handle & lock plate on 3rd floor bathroom door.
- 14- Test smoke detectors and check for 10 year batteries.
- 15- Clean & inspect fire place before use.
- 16- Seal sink & tub perimeters in master bathroom.
- 17- Seal tub perimeter in 3rd floor bathroom.
- 18- Seal tub perimeter & wall corners in garden level bathroom.
- 19- Adjust throw rod & stopper for powder room sink.
- 20- Seal counter perimeter in main kitchen.
- 21- Repair or replace cabinet door in main kitchen.
- 22- Examine range hood light in garden level kitchen.

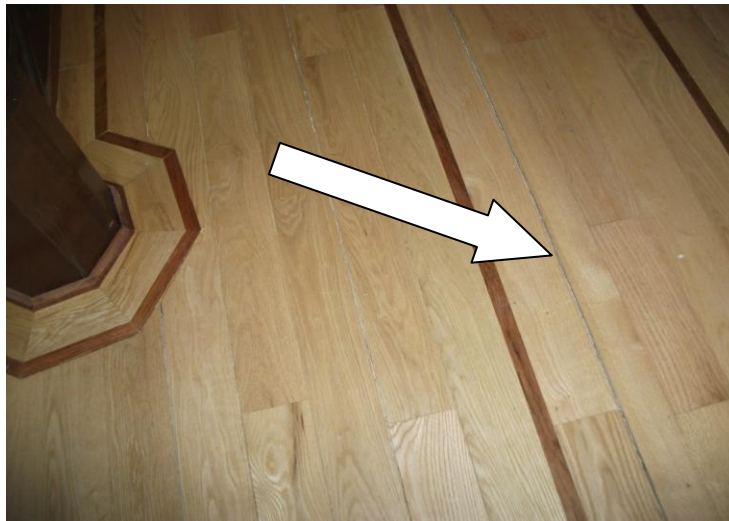
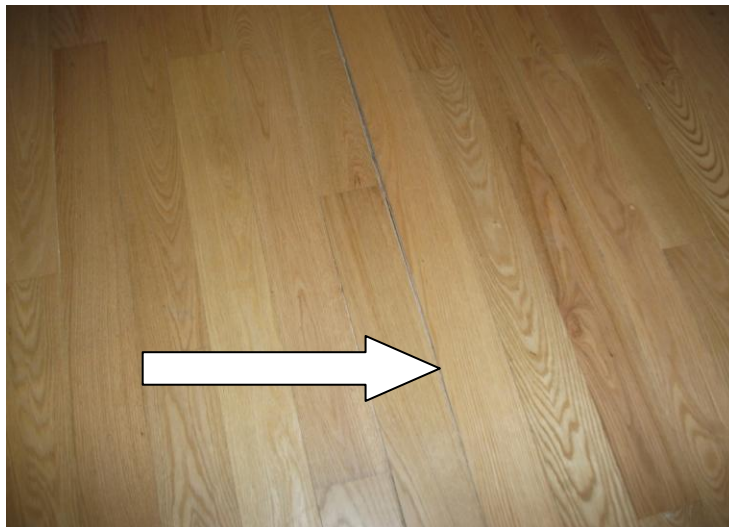
Because the floors and ceilings are finished we cannot examine the structure of the floor system. However the floors appeared to be sound and stable. The majority of the flooring throughout the apartment is wood while the bathroom floors are ceramic tile. It is apparent that the seams or joints in the wood on the 1st floor of the main house unit are far too wide spread. We were told, during this inspection, that the seller has agreed to replace this flooring. I would make sure to document this into your agreement and see that it is honored.

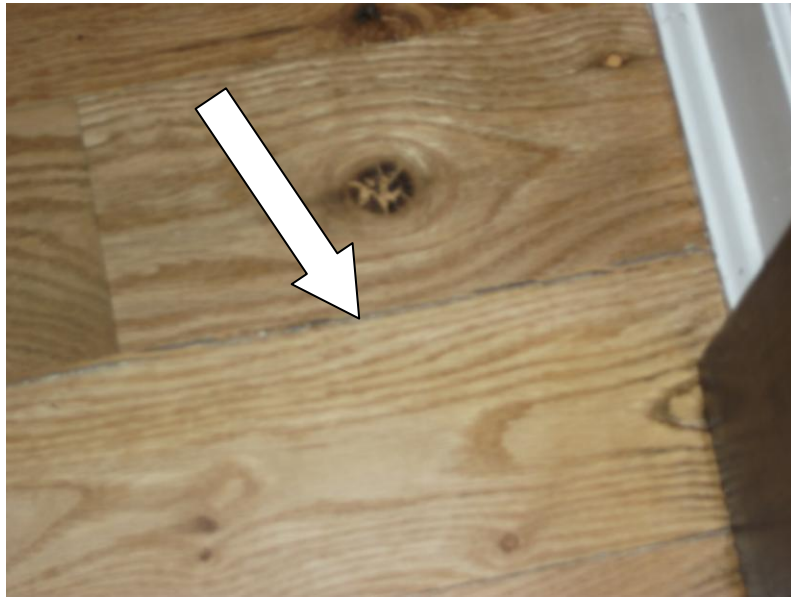
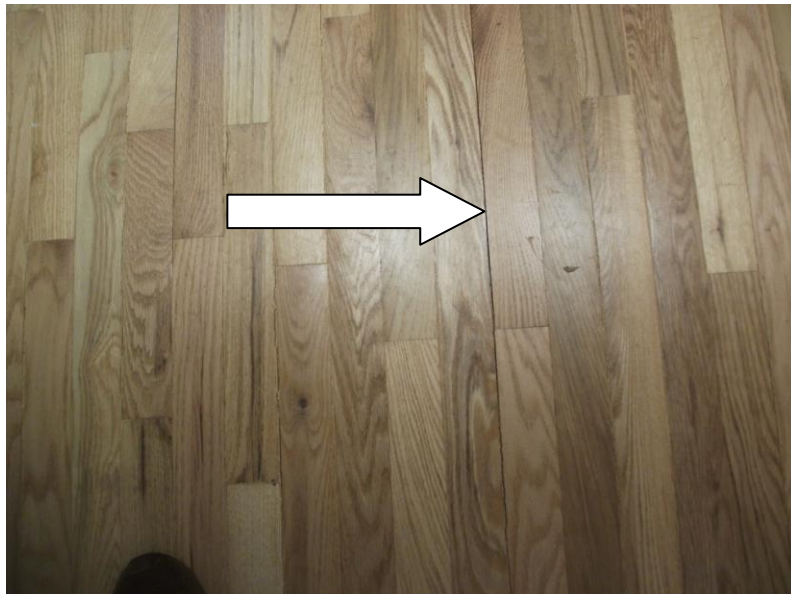
We also found a few gaps on the upper floors and in the garden level apartment. These gaps are not as large or severe as on the 1st floor. Several of these open seams appear to be easy to isolate and fill. You can then simply have those areas of the floor screened and finished instead of sanded.

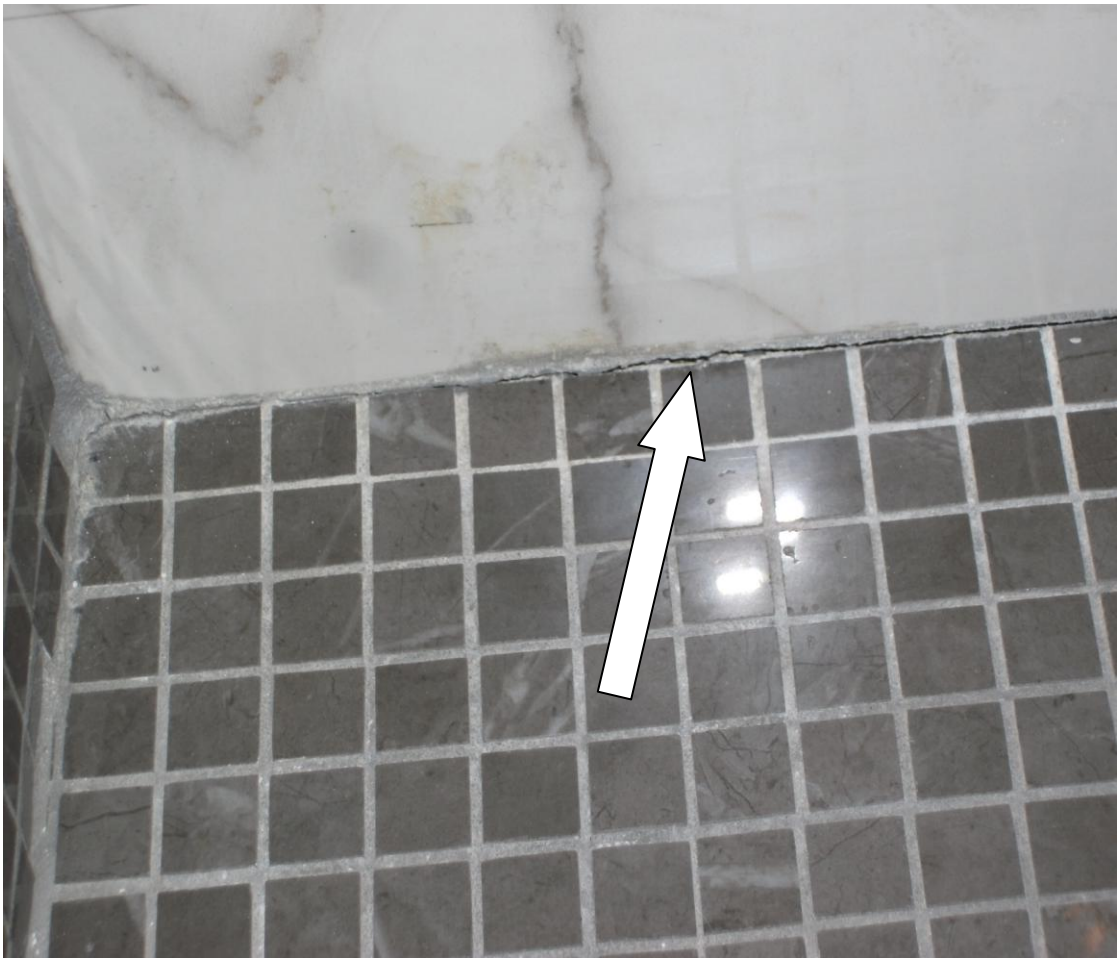
The ceramic tiles in the bathrooms is new and in very good condition. Again no loose or cracked tiles were observed and no loose grout was noted. I did find an open seam along the edge of the 2nd floor bathroom. This is not uncommon when new grout dries or minor settling occurs. I would be sure to have each bathroom floor perimeter examined and sealed to prevent water intrusion.

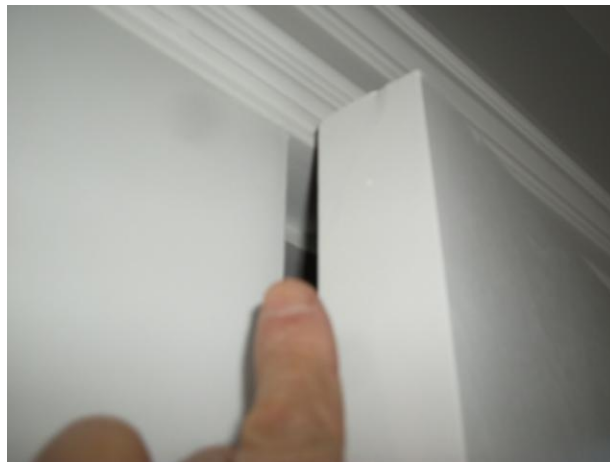
The interior doors were also examined and only a few minor adjustments will need to be attended to. The doors for the laundry closet are going to need magnets or catches in order to maintain the closed position.

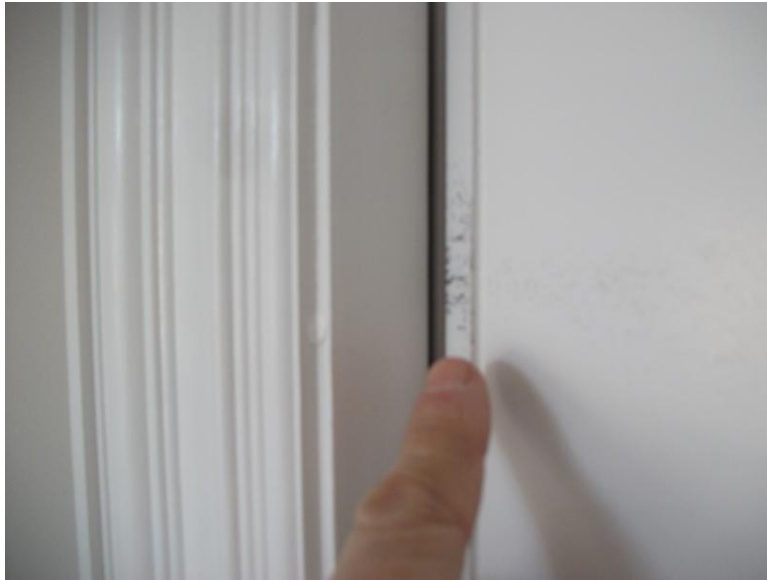
The pocket door to the master closet is rubbing and needs to be adjusted.

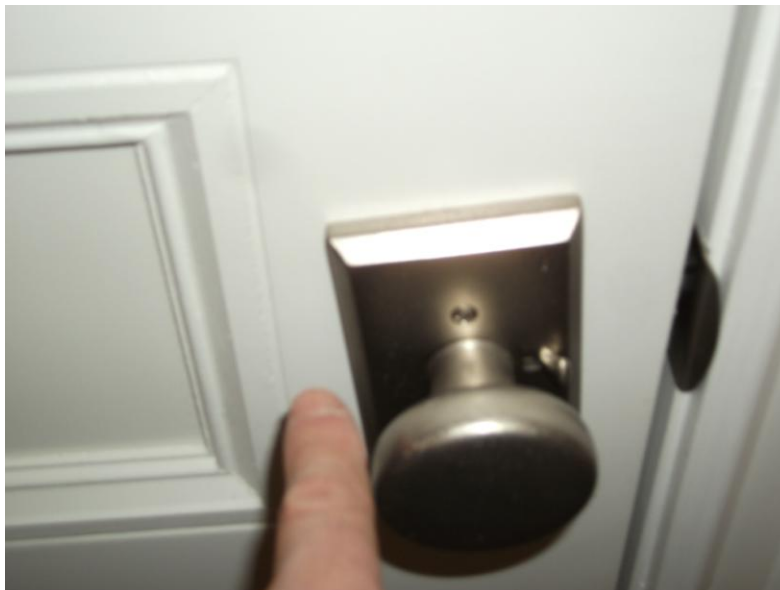
Finally the handle and lock plate for the 3rd floor bathroom door needs to be made secure.

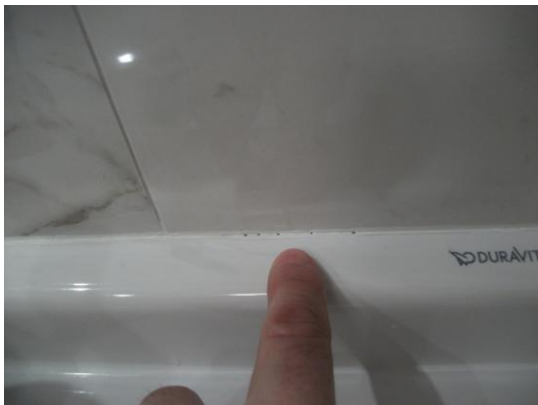
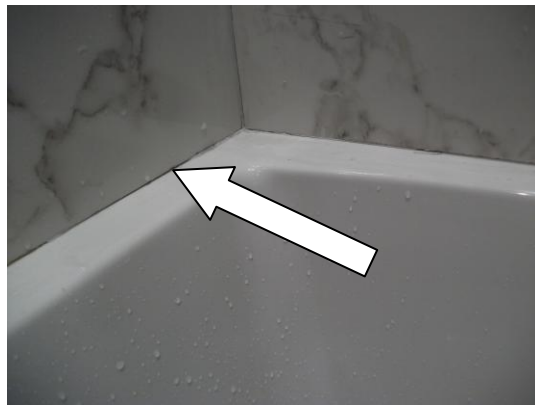
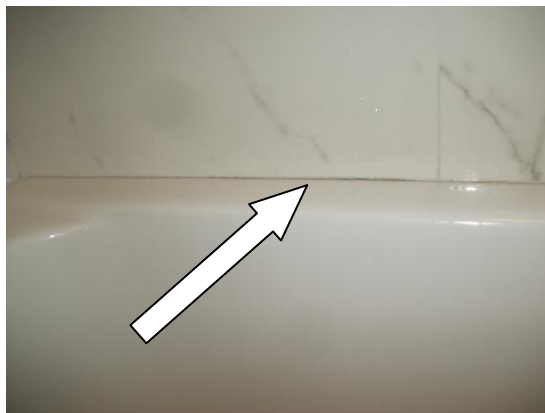
Upon running the water in the sinks and tubs or showers while flushing, no significant drop in water pressure was observed. A good stream of water was supplied on demand in the main house but the hot water to the garden level unit was not warm at the time of inspection. No sign of leaking or moisture was observed under or around the sinks or toilets and all drains were found to be working properly. The required exhaust fans and GFI outlets were installed and found to be in good working order. I would recommend sealing the sink and tub perimeters in the master bathroom and the tub perimeter of the 3rd floor bathroom.

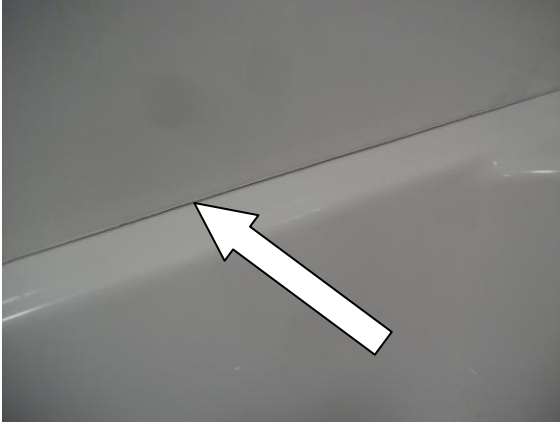
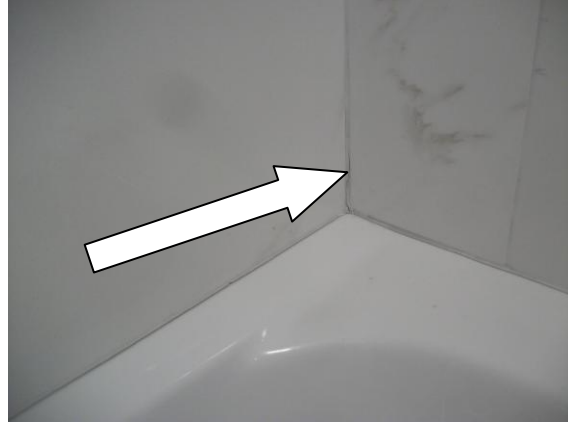
In the garden level bathroom the tub perimeter also needs to be sealed. However you will also need to touch up the grout in the tub corners.

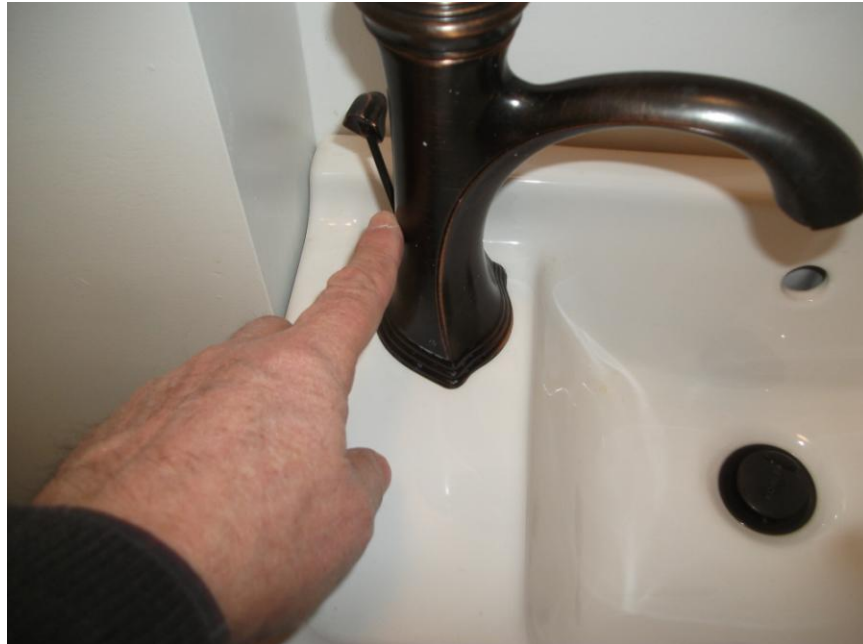
The sink stopper in the powder room is not linked to the throw rod. This will need to be adjusted for the sink to hold water.

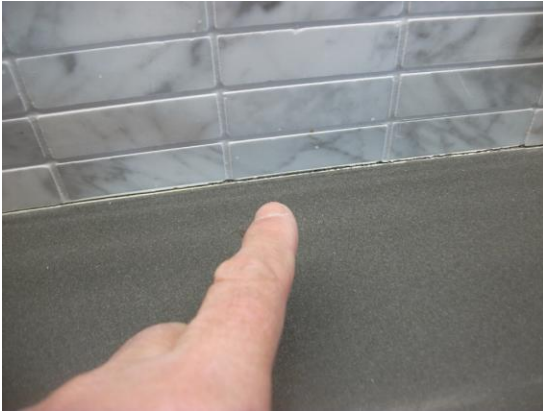
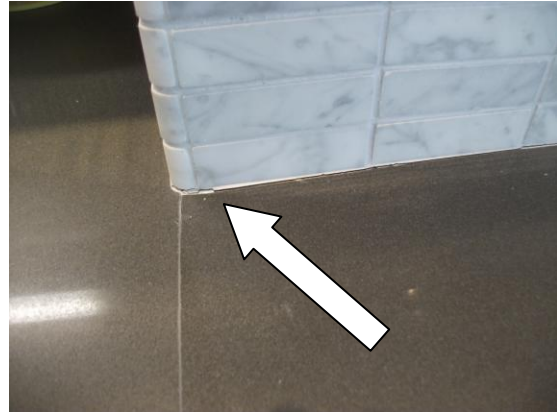
The cabinets are new and in excellent condition. The doors and drawers were examined and were found to be in good working order. The sink proved to have good water pressure on both the cold and hot side of the faucet. The drainage system was functioning properly when tested and the recommended GFI outlets were installed and working properly. I would recommend sealing the counter perimeter in the main kitchen to prevent water intrusion.

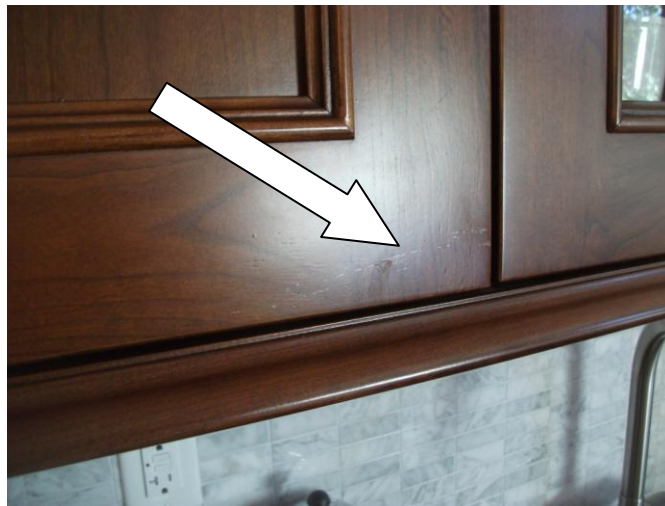
The cabinet door over the dishwasher in the main kitchen shows that the finish on the door is compromised. I would request that this door be re-finished or replaced.

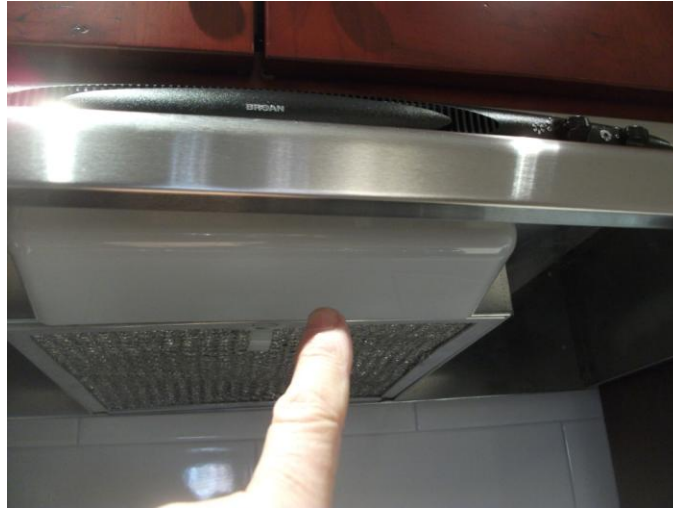
In the garden level kitchen we could not turn on the light for the range hood. It may just be the bulb. I would have it checked out.

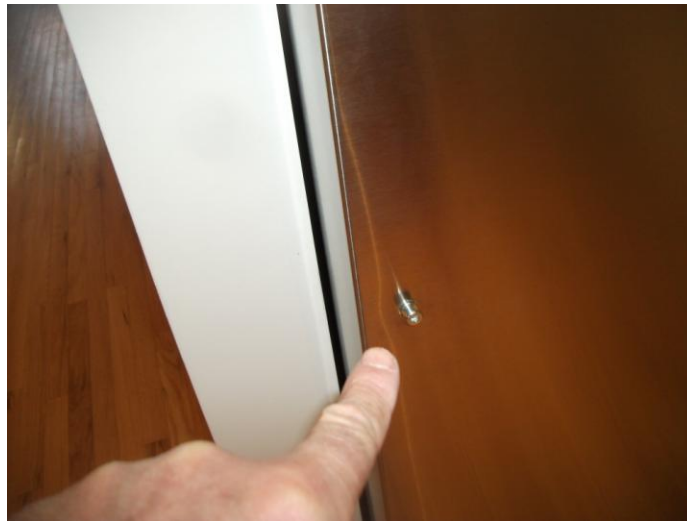
We also observed the handle on the refrigerator is missing in the garden level kitchen.

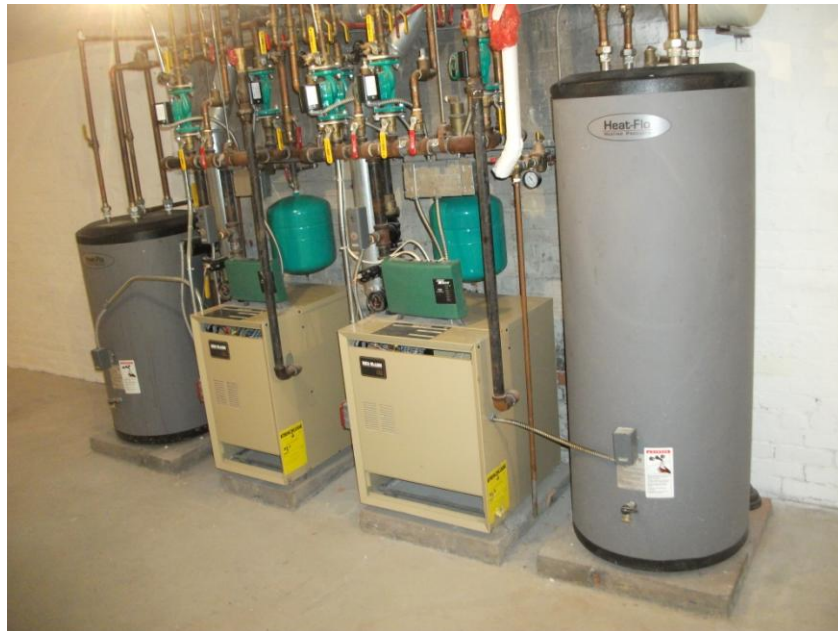
The heat and hot water for domestic use are provided by 2 Weil Mc Lain gas fired hot water heaters, one for each unit. Hot water is circulated through cast iron radiators throughout the building for distribution. Each floor of the main house has a thermostat which controls the heat for that floor and the garden apartment has one central thermostat. Each of these thermostats controls a separate loop or zone that circulates hot water from the boiler when demanded by the thermostat. In the same way separate zones are circulated through hot water storage tanks to heat the water that is stored in them. The main house has a 60 gallon storage tank and the garden apartment a 40 gallon tank. For some reason the garden apartment was not receiving hot water at the time of inspection. This will need to be checked out and corrected.
