Building Description

This is a stone, brick and wood structure that was built in approximately 1899 and has recently undergone a complete renovation. It is a 3 ½ story building that house 2 residential units and a basement below the garden level unit. The property also includes a back yard that has been finished with a stone patio and small garden space. We will proceed to report on the readily accessible structural and mechanical components of the building and also to report any apparent safety or health issues.

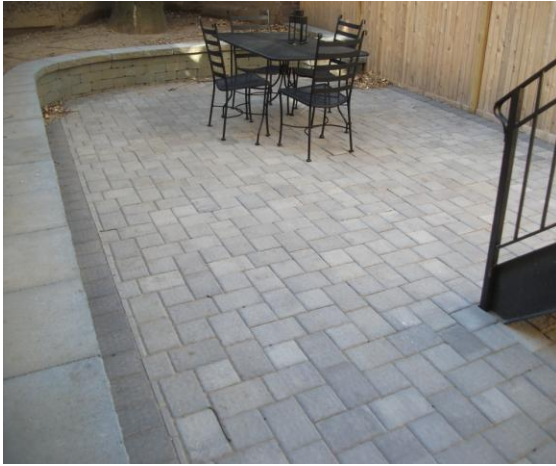
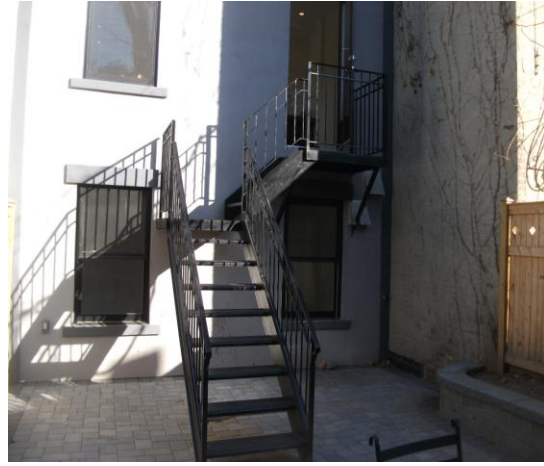
The property at the rear of the building consists of a small garden space and a large patio area which can be accessed from the main house apartment. The stairs to the rear yard are constructed of steel and are equipped with the appropriate hand rails.

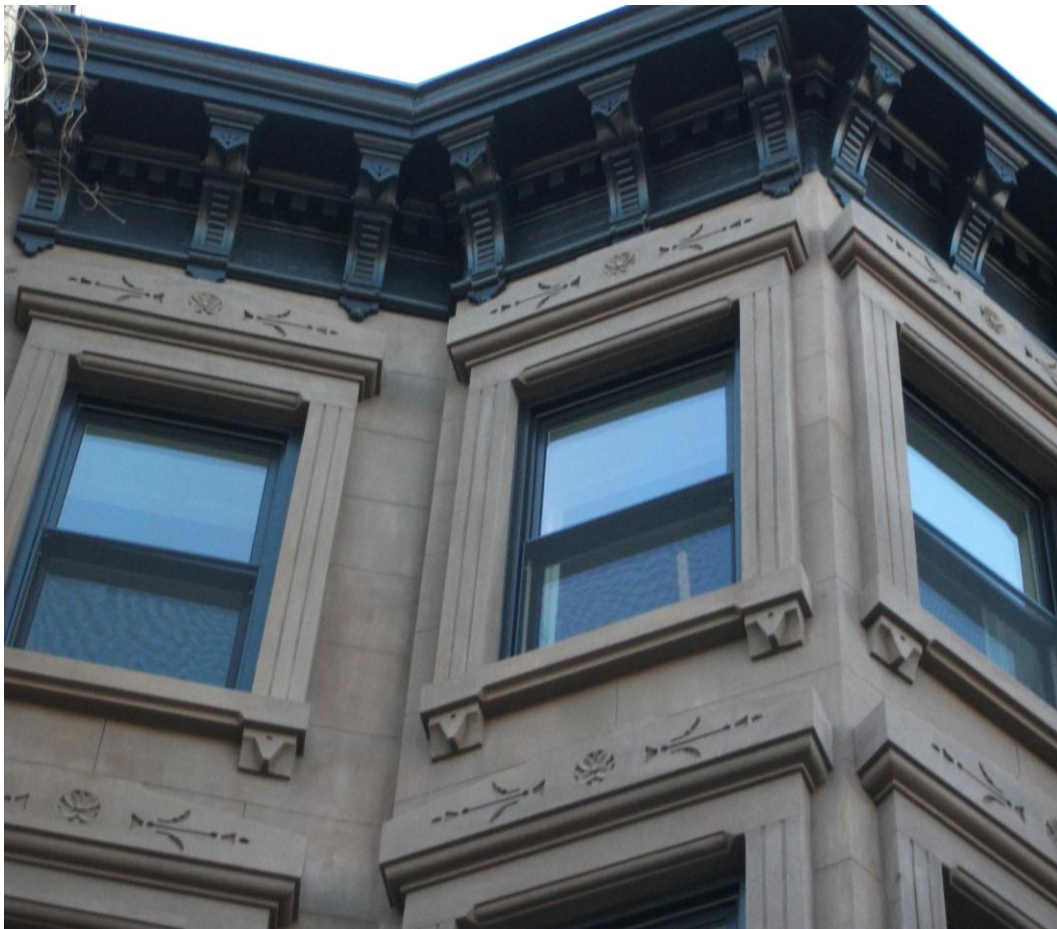
The front façade of this building is the original brownstone that has been completely restored. No evidence of cracking or unusual settling was observed. All visible trim around the windows and doors appeared to be properly sealed. The wood cornice and soffit work at the roof's edge has also been restored and painted. No loose or peeling paint was observed and the seams that were visible from the ground appeared to be properly sealed.

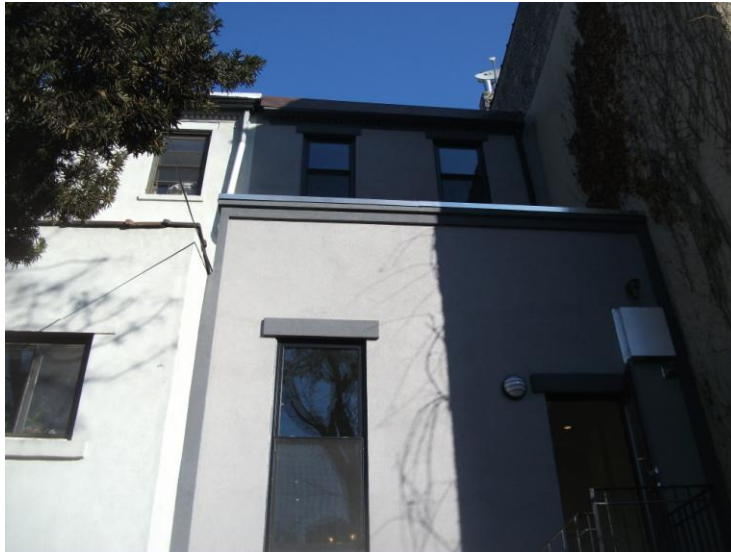
The rear of the house has been covered with a coat of stucco. Again no cracking, chipping or peeling was noted and all visible edges and seams appeared to be properly sealed to prevent water intrusion.

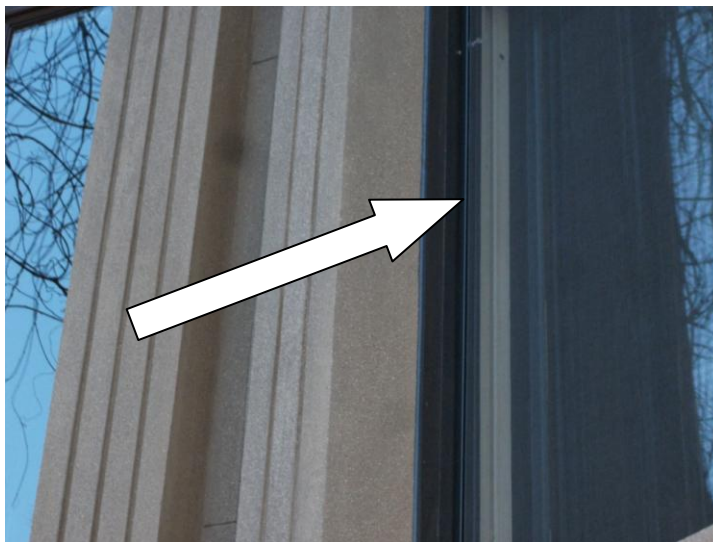
The windows throughout the building have been replaced with new double hung thermo panes. From the outside these windows appear to be properly installed. A generous bead of caulking or sealant was observed at the window perimeters.

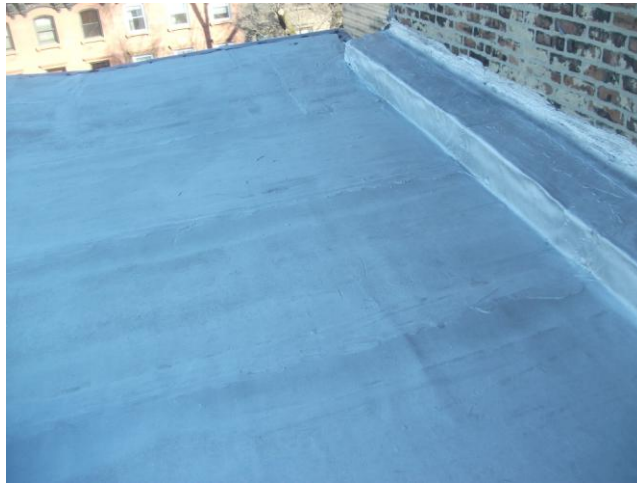
The roof is covered with the traditional bituminous based roll out roofing material. It is apparent that our roof has recently been re-coated. No soft or spongy spots were observed in the roof surface.

It is hard to forecast how long the existing roof will last. I would recommend re-coating the roof periodically until it is time for a new one

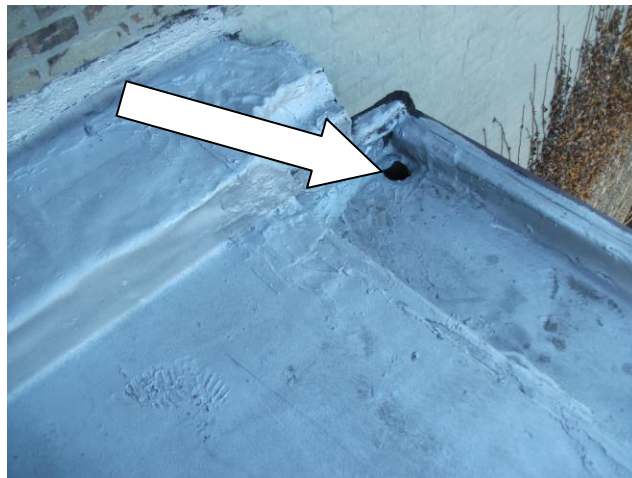
The skylight and other roof penetrations appeared to be properly sealed and the roof drain was found to be clear.

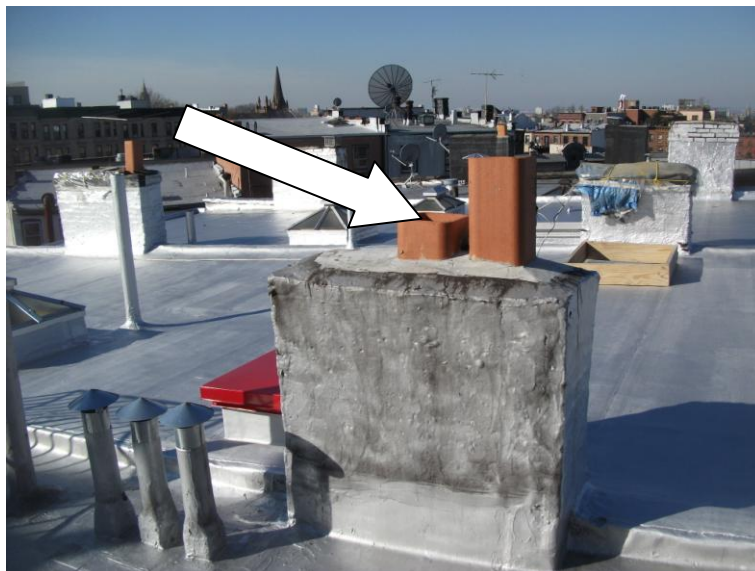
The chimney appeared to be in good condition. The brick has been coated to remain water proof and the chimney flues at the termination point are new.

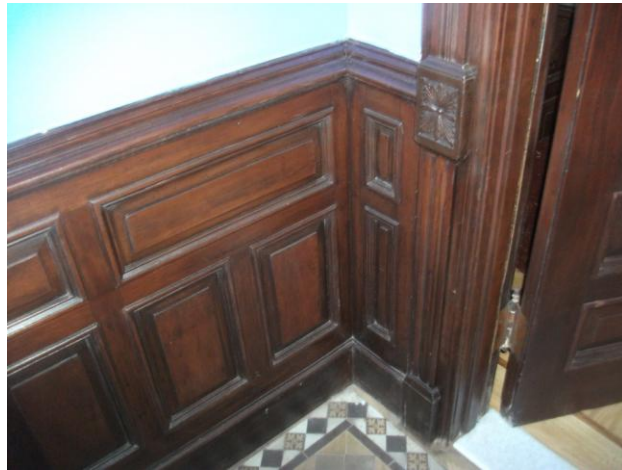
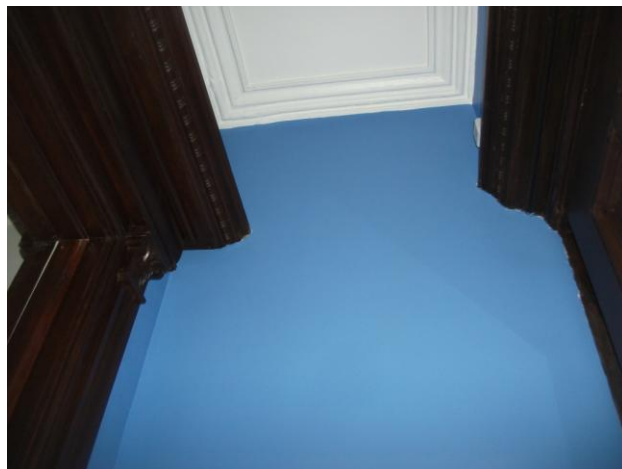
The floor in the foyer is ceramic tile. These tiles are in good condition. No cracked or loose tiles were observed. The walls are composed of the original wood panel wainscot at the bottom with what appears to be plaster and plaster trim at the ceiling. The wainscot was in good condition and no peeling or cracking was observed on the walls or ceiling.

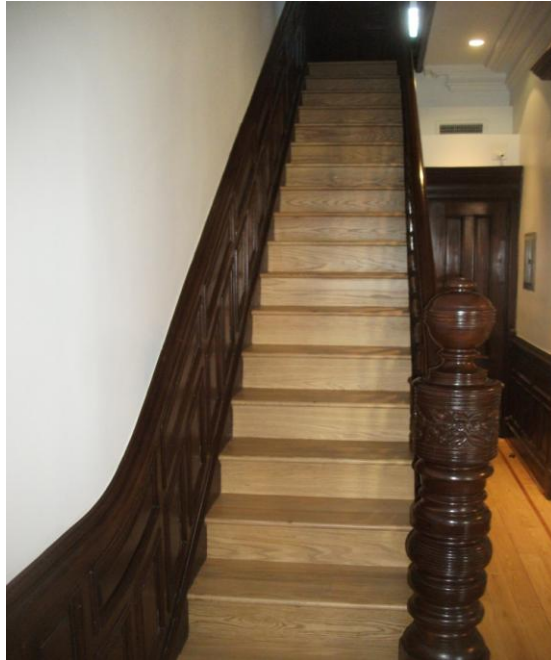
These stairs have been equipped with the required continuous handrails which are original and have been re-finished. Most of these railings proved to be properly secured.

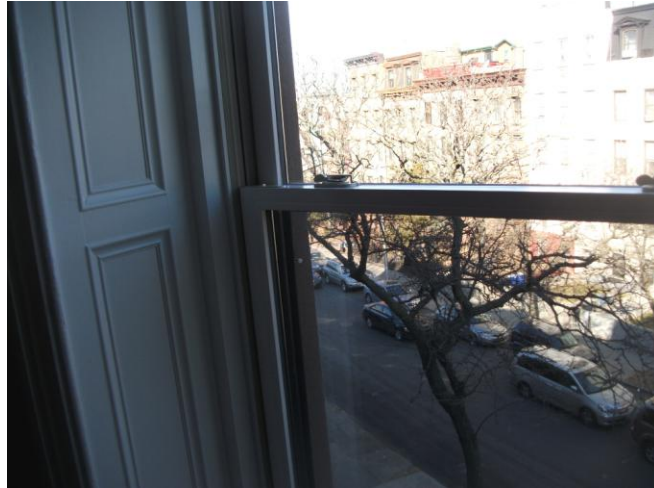
The windows throughout this building are new thermo panes. Each window appeared to be tight and properly trimmed. The windows that could be approached were examined and found to be in good working order. All locks and screens were functioning well.

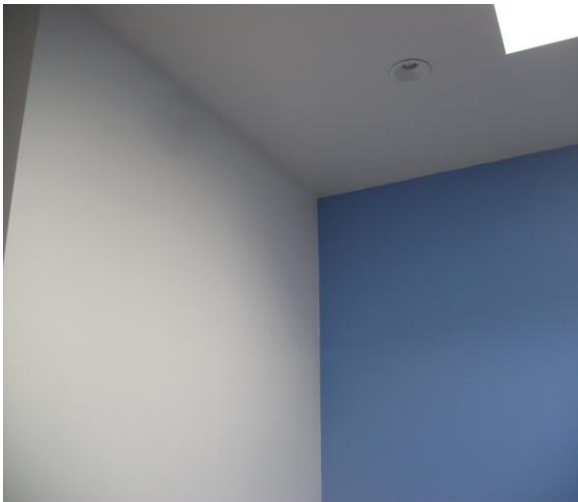
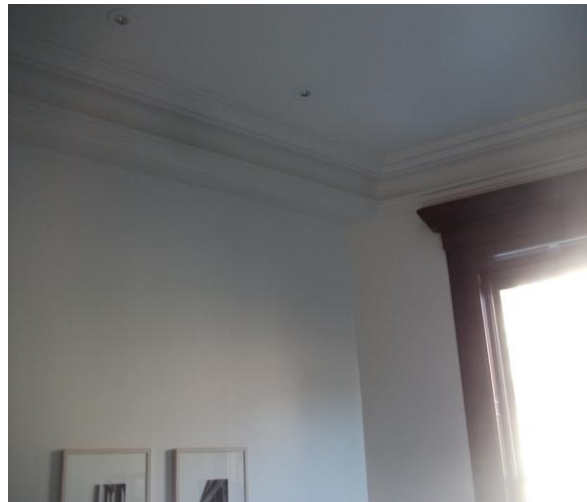
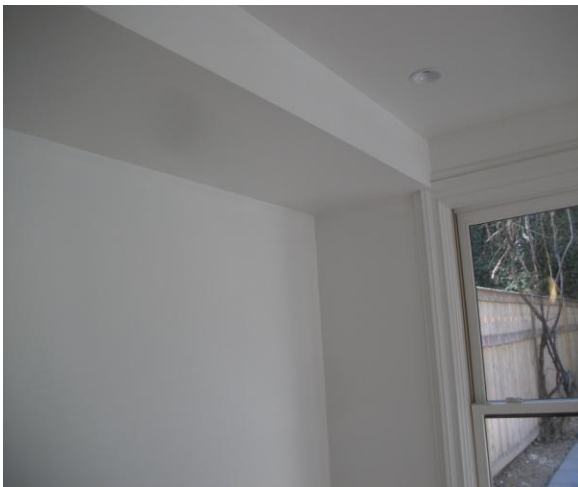
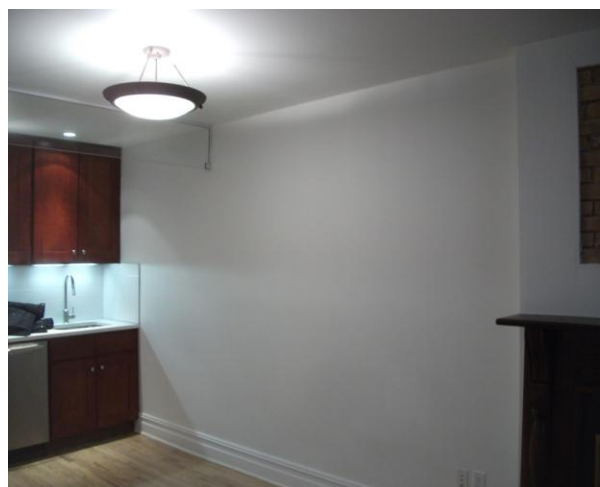
The walls and ceilings throughout both units are composed of drywall with the possibility of some plaster in some places. The painted finish is clean and it is apparent that these walls and ceilings are in very good condition. No unusual peeling which could imply moisture or cracking which could imply unusual settling was observed.

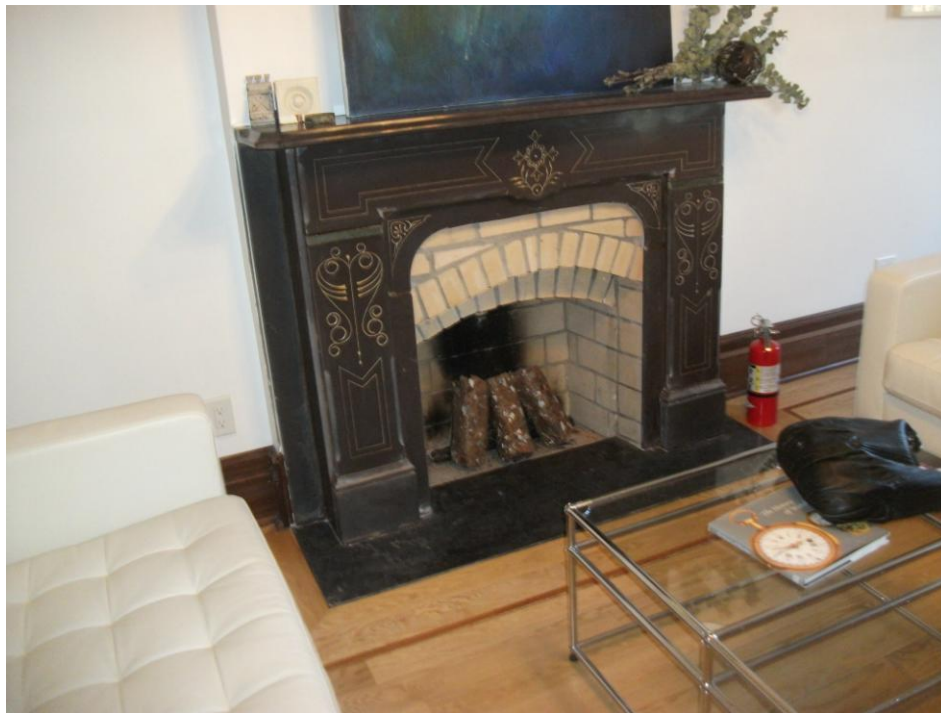
The floors, windows, doors, walls and ceilings in these spaces have already been reported on. Each of these spaces has been equipped with an adequate number of electric outlets. The outlets that were examined proved in good working order. Each of these spaces appeared to be well lit and properly ventilated. I would recommend having the seller unpack and test the smoke detectors and make sure that they are equipped with 10 year back up batteries. There are several non- working fire places in the building. However at the center of the main living room is a working fire place. We were informed that this fire place has been re-built to the roof. I would recommend having the fireplace cleaned and inspected before use.

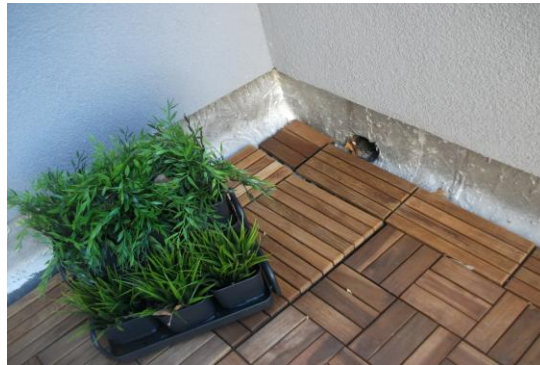
The master bedroom roof deck is covered with cedar patio squares. However the roof drain was visible in the corner of the deck. I would recommend keeping this drain clear and free of debris at all times.

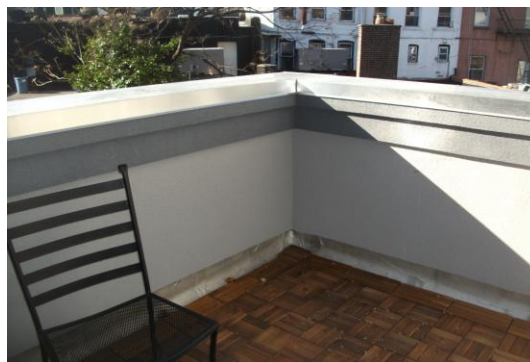
The parapet wall serves as the guard rail. The copings for the wall appeared to be properly sealed at the seams or joints.

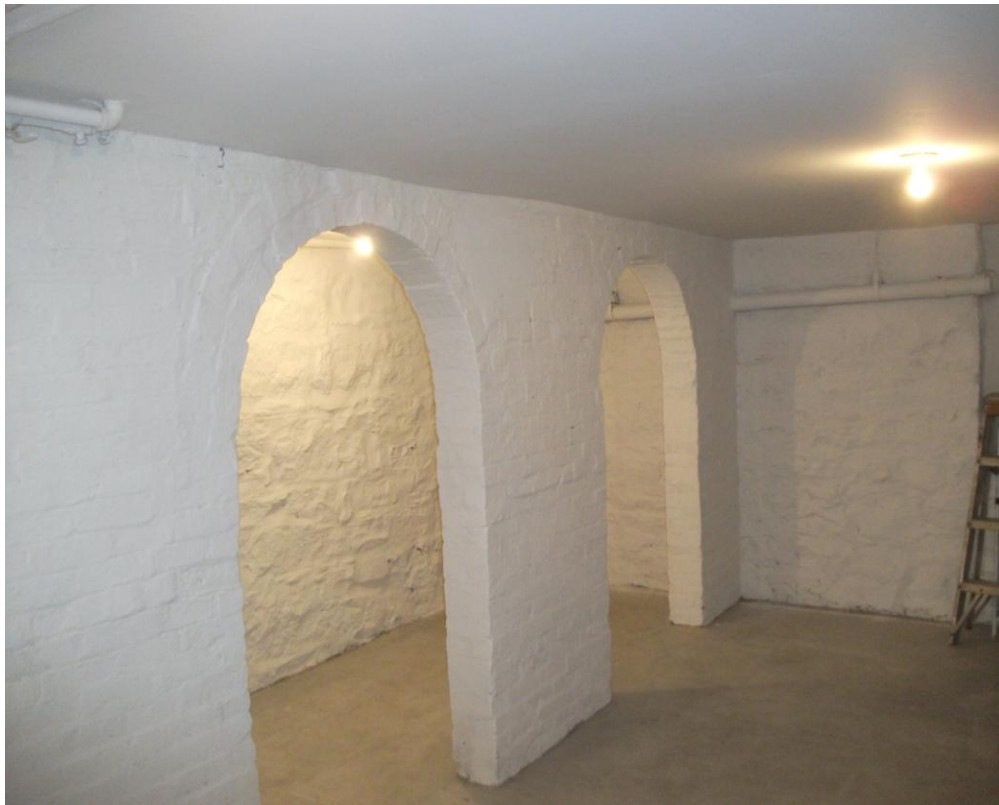
The basement floor is concrete which showed no unusual cracking for a building of this age. The foundation walls are brick and stone. These walls have recently been covered or painted with a water proof coating. No bulging or cracking was observed and no evidence of water intrusion was noted at the time of this inspection. The mid-span girder for the building is a brick wall with arches that showed no evidence of movement or unusual settling. All visible penetrations in the ceiling have been properly sealed for fire safety. The vault used to access the basement from the street has been provided with a new hatch door equipped with fresh air vents that provide oxygen for the boiler's fire.

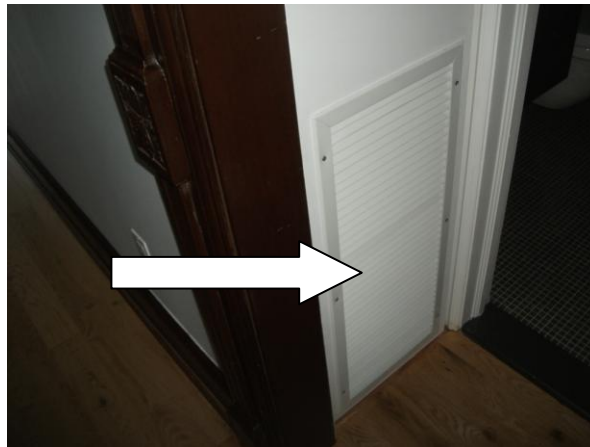
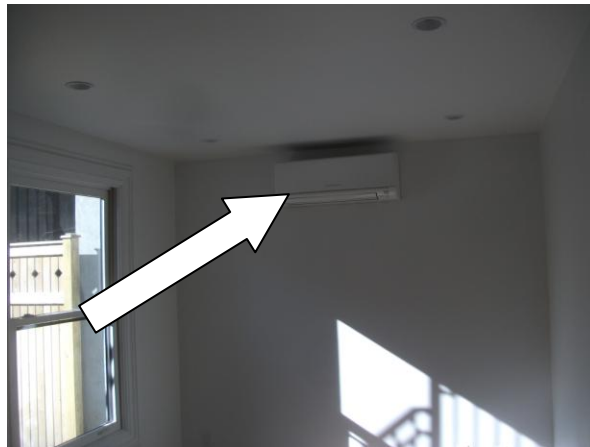
The air conditioning is provided by 4 compressors on the roof and several air handlers in the house. The main house has an air handler on each level and the garden apartment has 3 wall hung units. The compressors compress a coolant which then becomes cold and is circulated through a coil in the air handlers where air blows over the coil to distribute cold air to the rooms. We did not test the AC because when the outdoor temperature is below 60° you can damage the equipment. I would recommend that you have your air handlers serviced periodically to clean or replace the air filters and to make sure the condensation lines are clear.

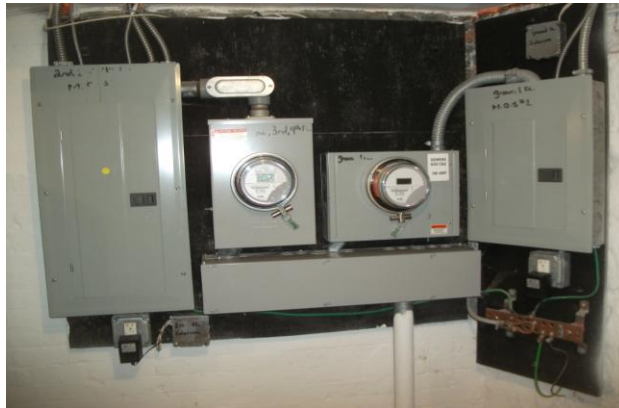
The electric enters through the basement and was found to be properly grounded to the main water line. Each unit is separately metered for billing. The main house has been provided with a 200amp service and the garden apartment a 100amp service. This should be adequate for the present demand. All visible wiring was in conduit or the recommended BX cable.
